February 15, 2019

RE: Town of Lake Santeetlah Pipe Failures

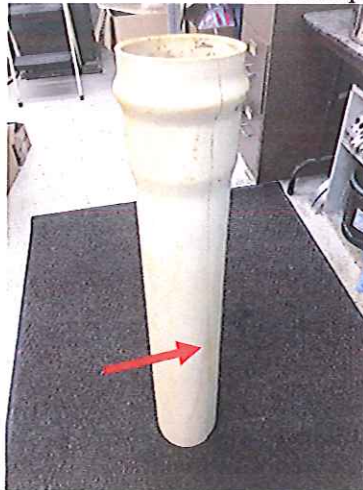
The sample received for analysis is a piece of Diamond Plastics PVC pipe manufactured to ASTM D2241 DR21 including the bell. The pipe wall has cracked in primarily a straight line from the end of the bell to the end of the sample as shown in Photo 1 below.

Initial visual inspection of the sample indicated that there appeared to be some staining on a portion of the sample received noted by the arrow in Photo 1. Further examination indicated that in the area noted with the stain, there appeared to be a deflection of the pipe wall.

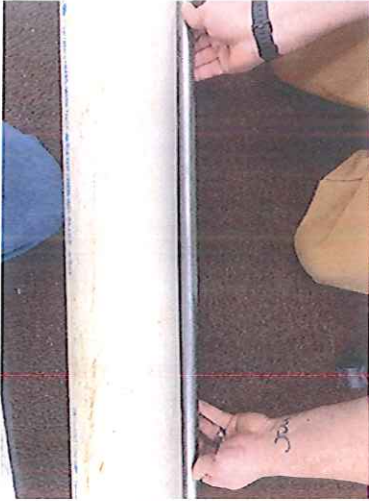
A 1-inch diameter straight rod was used to determine that there was approximately 3/16" of localized deflection of the pipe wall as indicated in Photo 2 and 3 below.

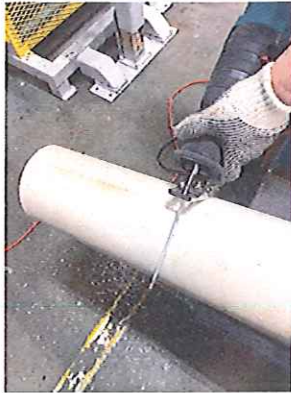
Photo 4

The deflected area of the pipe was then removed to aid in inspection of the crack from the inside of the sample as documented in Photos 4, 5, and 6 below.

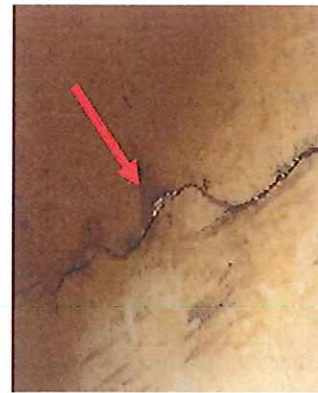
Photo 6

The section removed was then cut longitudinally to allow inspection of the crack in the stained area noted in Photo 1 earlier. A small piece of something was noticed protruding into the pipe from the outside as indicated by the arrow in Photo 6. Photos 7-11 are of the longitudinal cut and surface of the crack in the stained area.

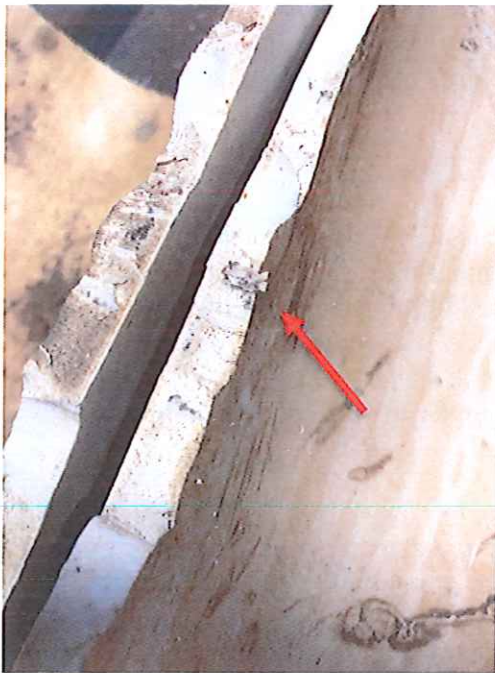
Photo 10

The piece of material noted by the arrow in photo 6 is also shown and noted by an arrow in photo 10. The arrow in Photo 11 is showing the fracture that we believe started the crack. The crack in the area where the pipe was deflected and stained is 4-5 inches in length and has a different fractur pattern than the rest of the crack that runs the length of the sample.

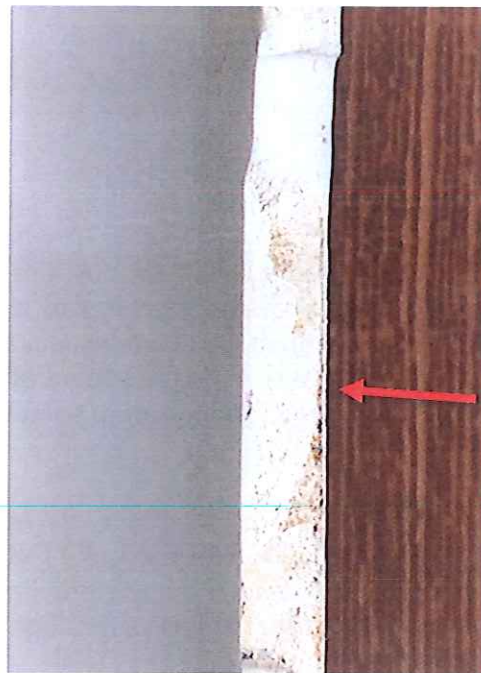
Photo 11

The damage in this area; in my opinion, is where the crack started and may be the result of damage from a fork on lifting equipment when unloading the pipe from trucks when shipped.

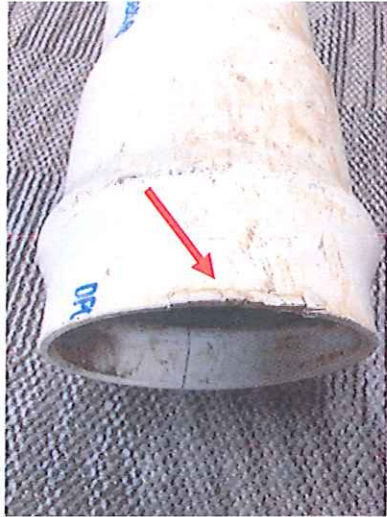
The damage noted in Photo 12 and 13 we believe is the result of ‘barring’ the pipe joints together during installation or impacts from a hammer used for assembly which is commonly on the top of pipe bells in which a wood block is not used to cushion the bar or hammer as recommended in our installation guide. The barring/hammer mark indicates the crack would have been on the bottom of the pipe as installed, which also leads to the question if the damage is the result of something under the pipe after installation causing a stress and then fracture.

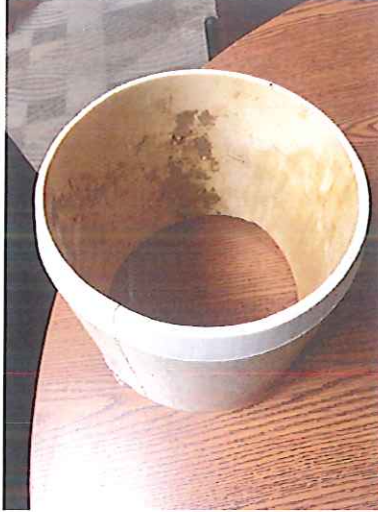
Photo 14 below shows the passing results of testing performed to ASTM D2152 Standard Test Method for Adequacy of Fusion of Extruded Poly (Vinyl Chloride) (PVC) Pipe and Molded Fittings by Acetone Immersion. Pipe wall thickness measurements indicated that the wall thickness of the sample ranges from a minimum of 0.331 inches with a maximum of 3.342 inches. ASTM D2241 specifies the minimum wall thickness to be 0.316 inches with a plus tolerance of 0.038 inches. The pipe sample meets this requirement.

There were no manufacturing defects found in the testing of the pipe sample received. If we may be of further assistance in this matter, please do not hesitate to call us. For your convenience, please use our toll-free phone 1-800-PVC-PIPE (1-800-782-7473.)
